Case 324 : Narrative

Case Vehicle (A): 2000 Dodge
Type: Stratus SE, 4-door sedan
Driver: 20-year-old female
CDC: 12-FDEW-5

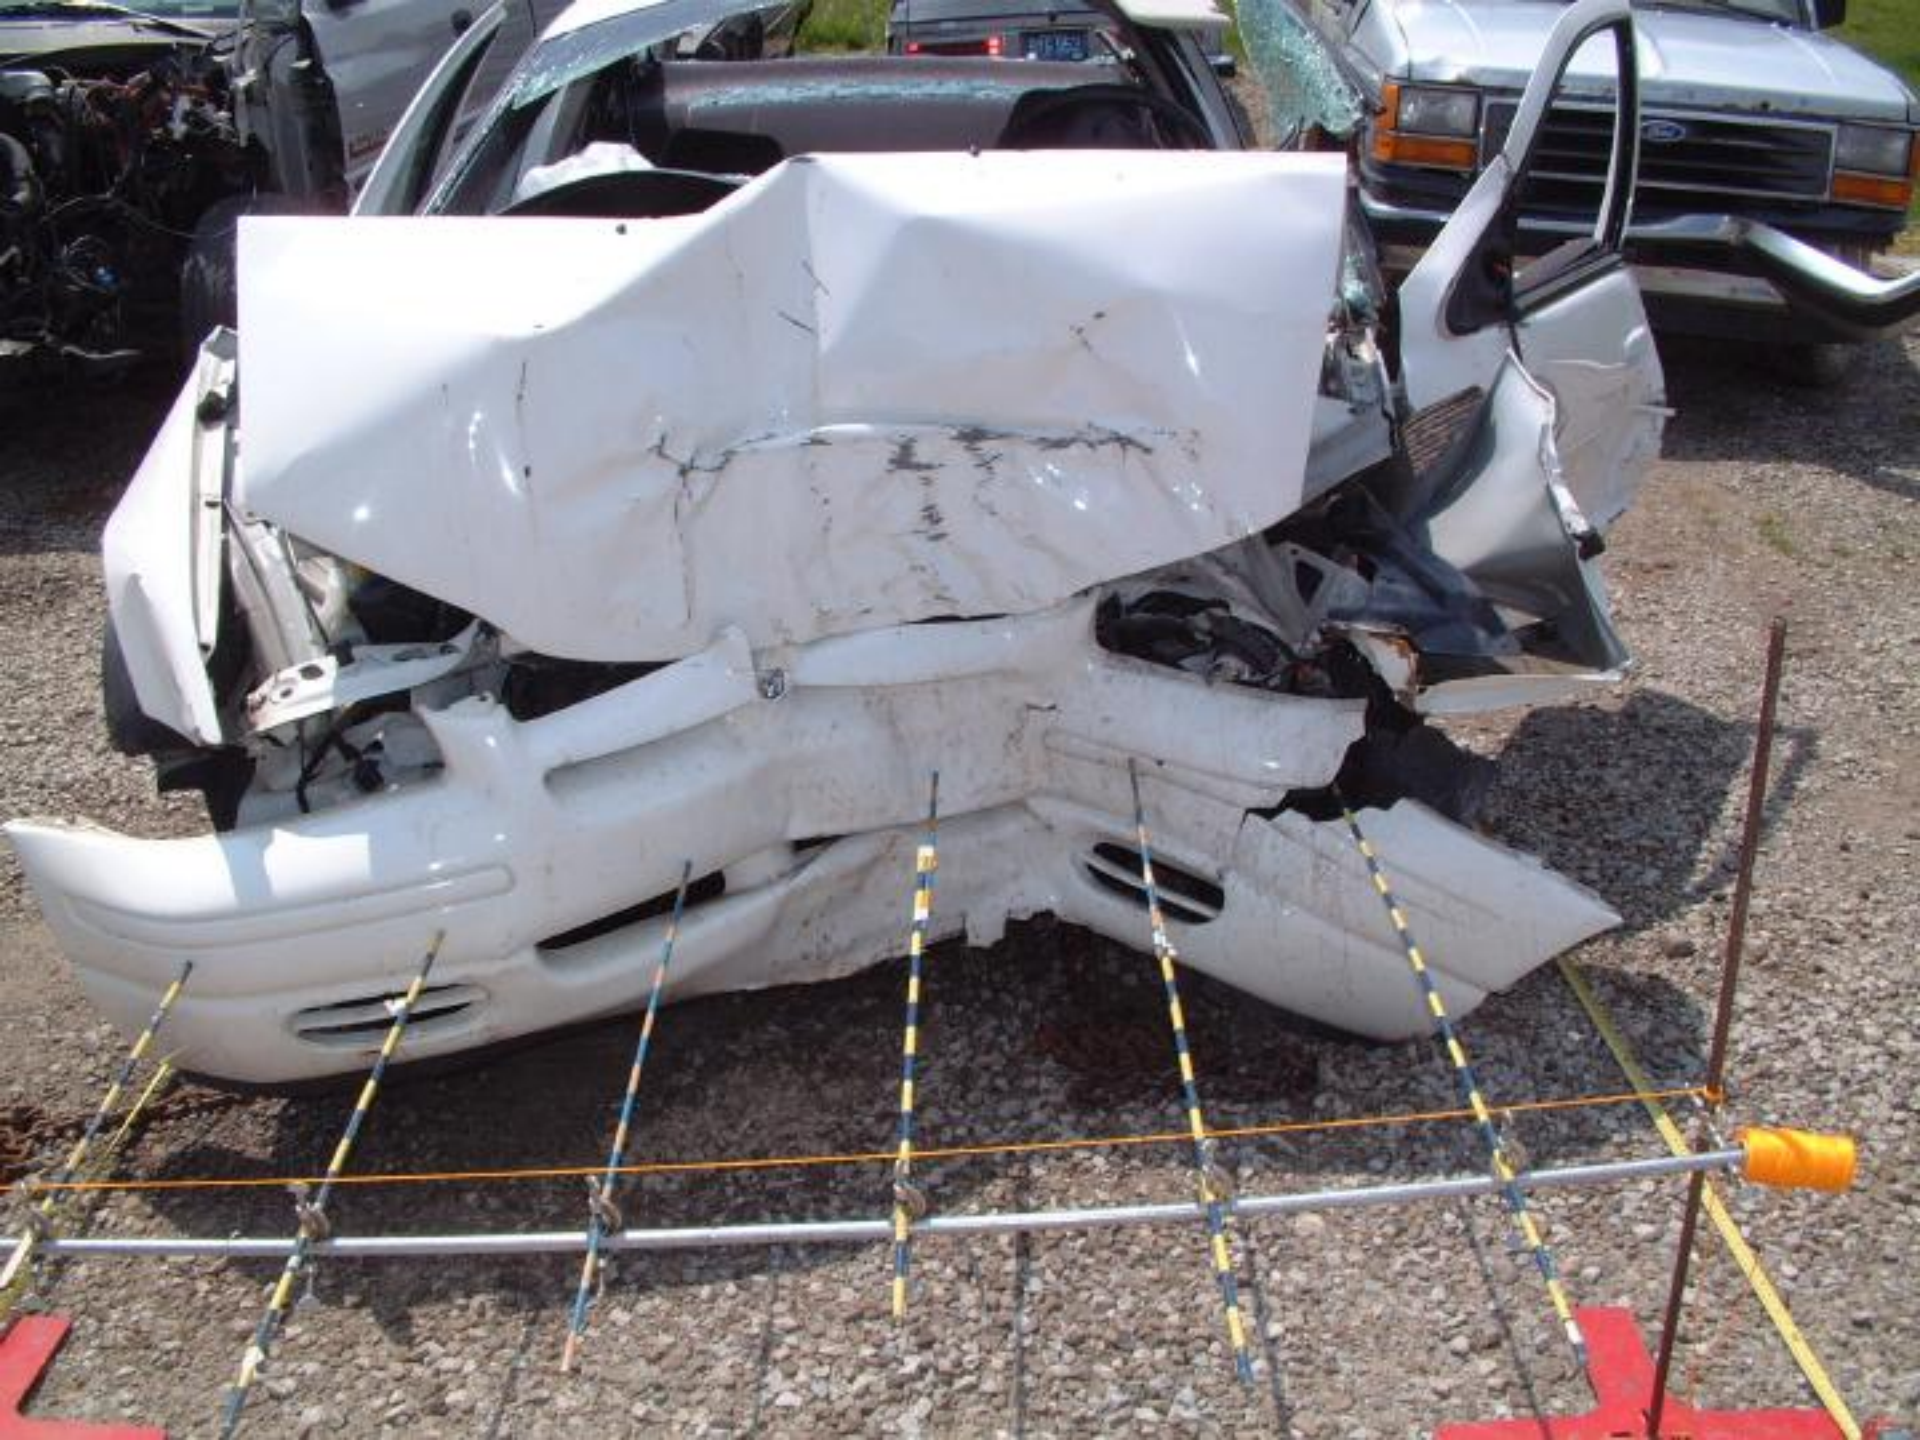
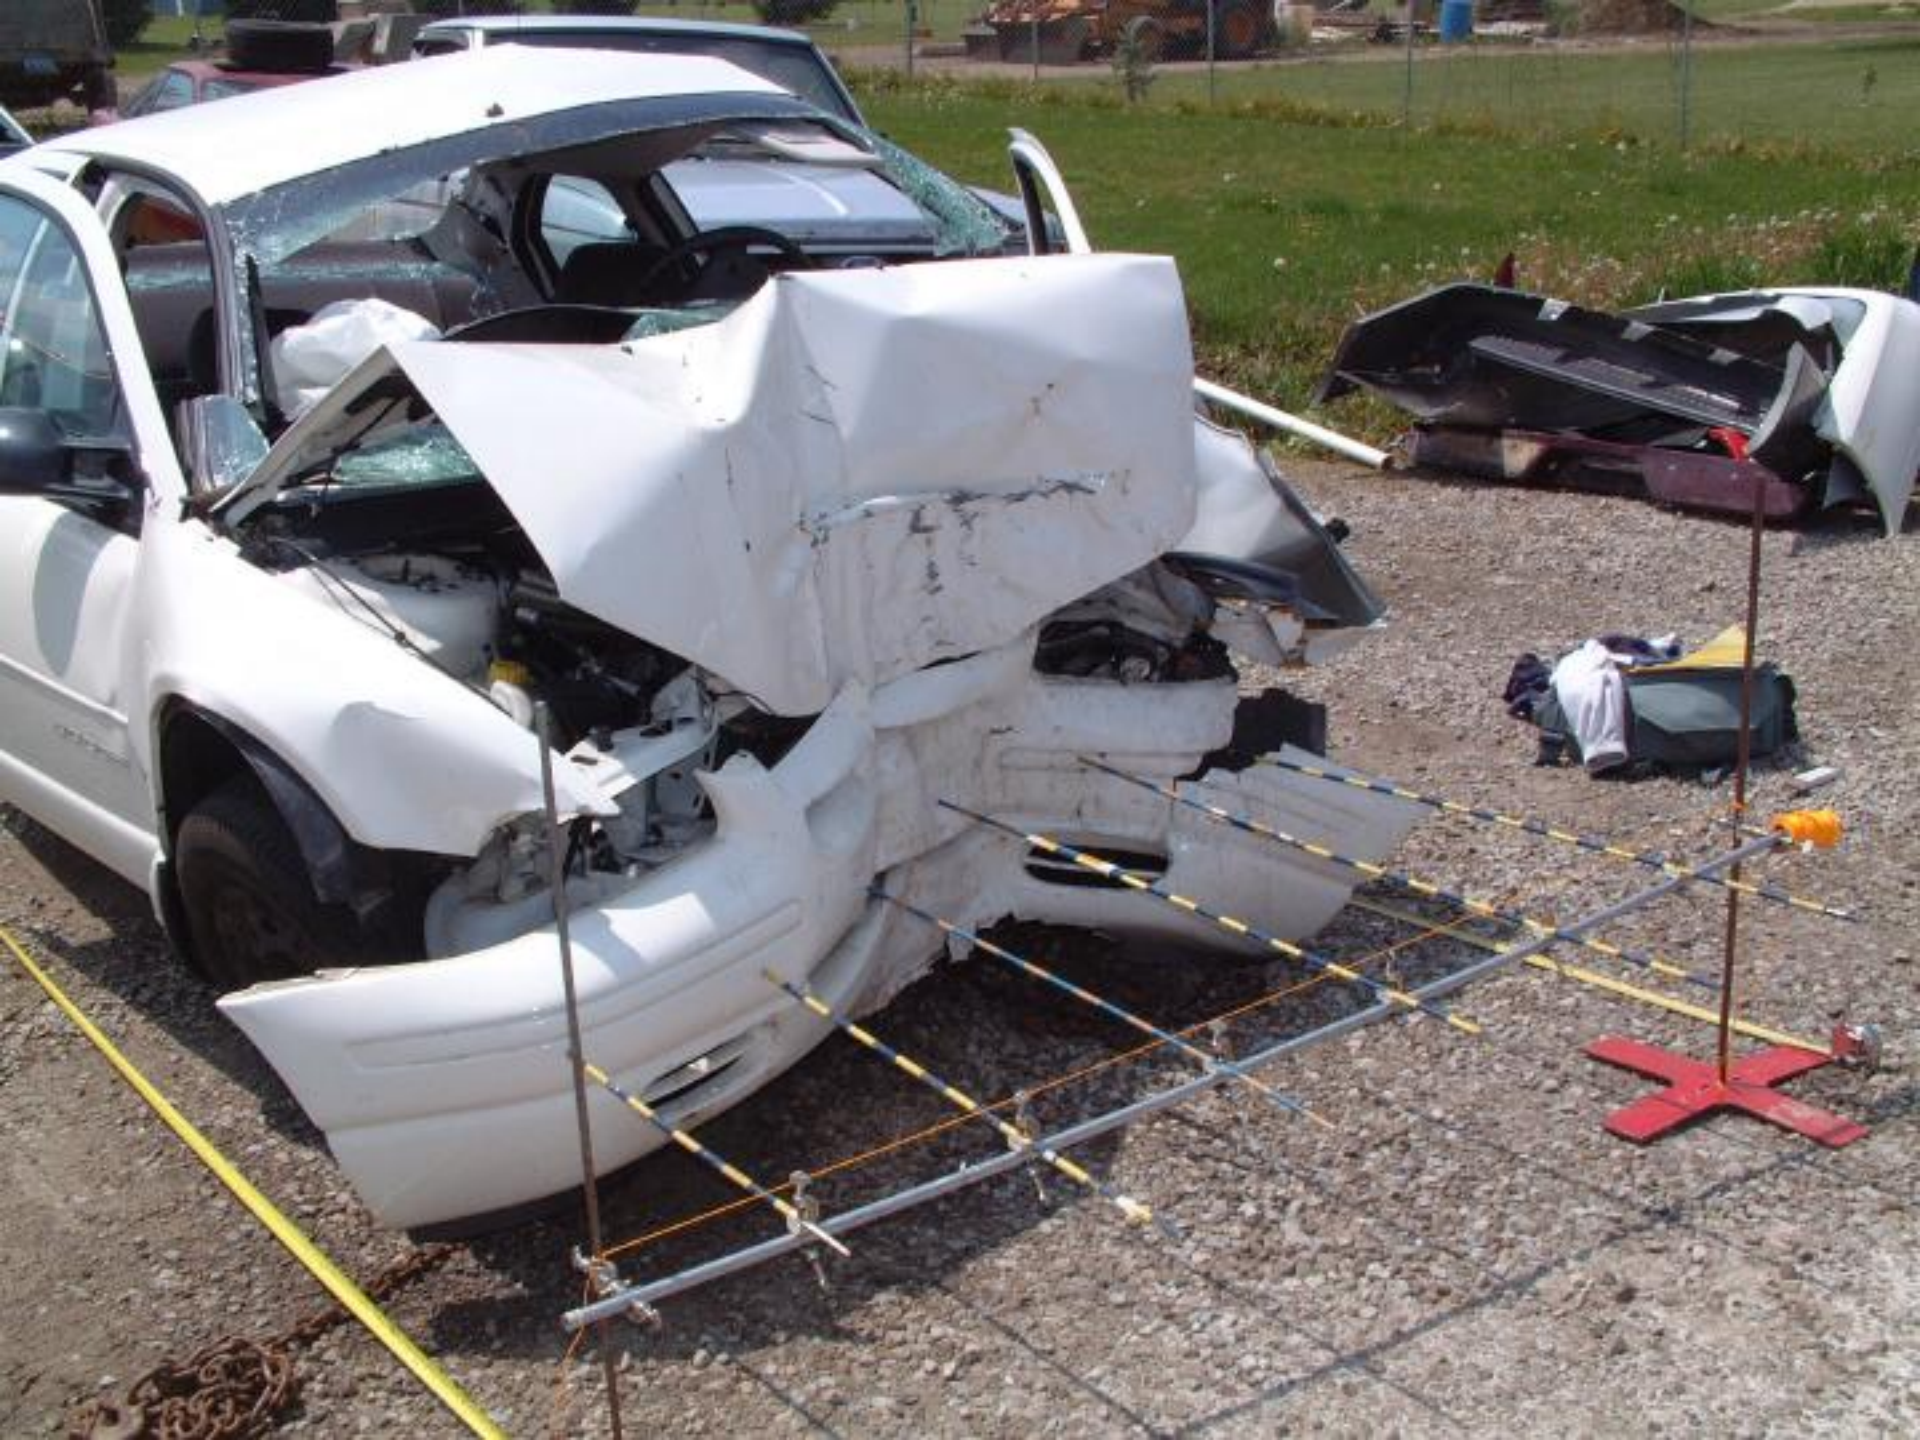
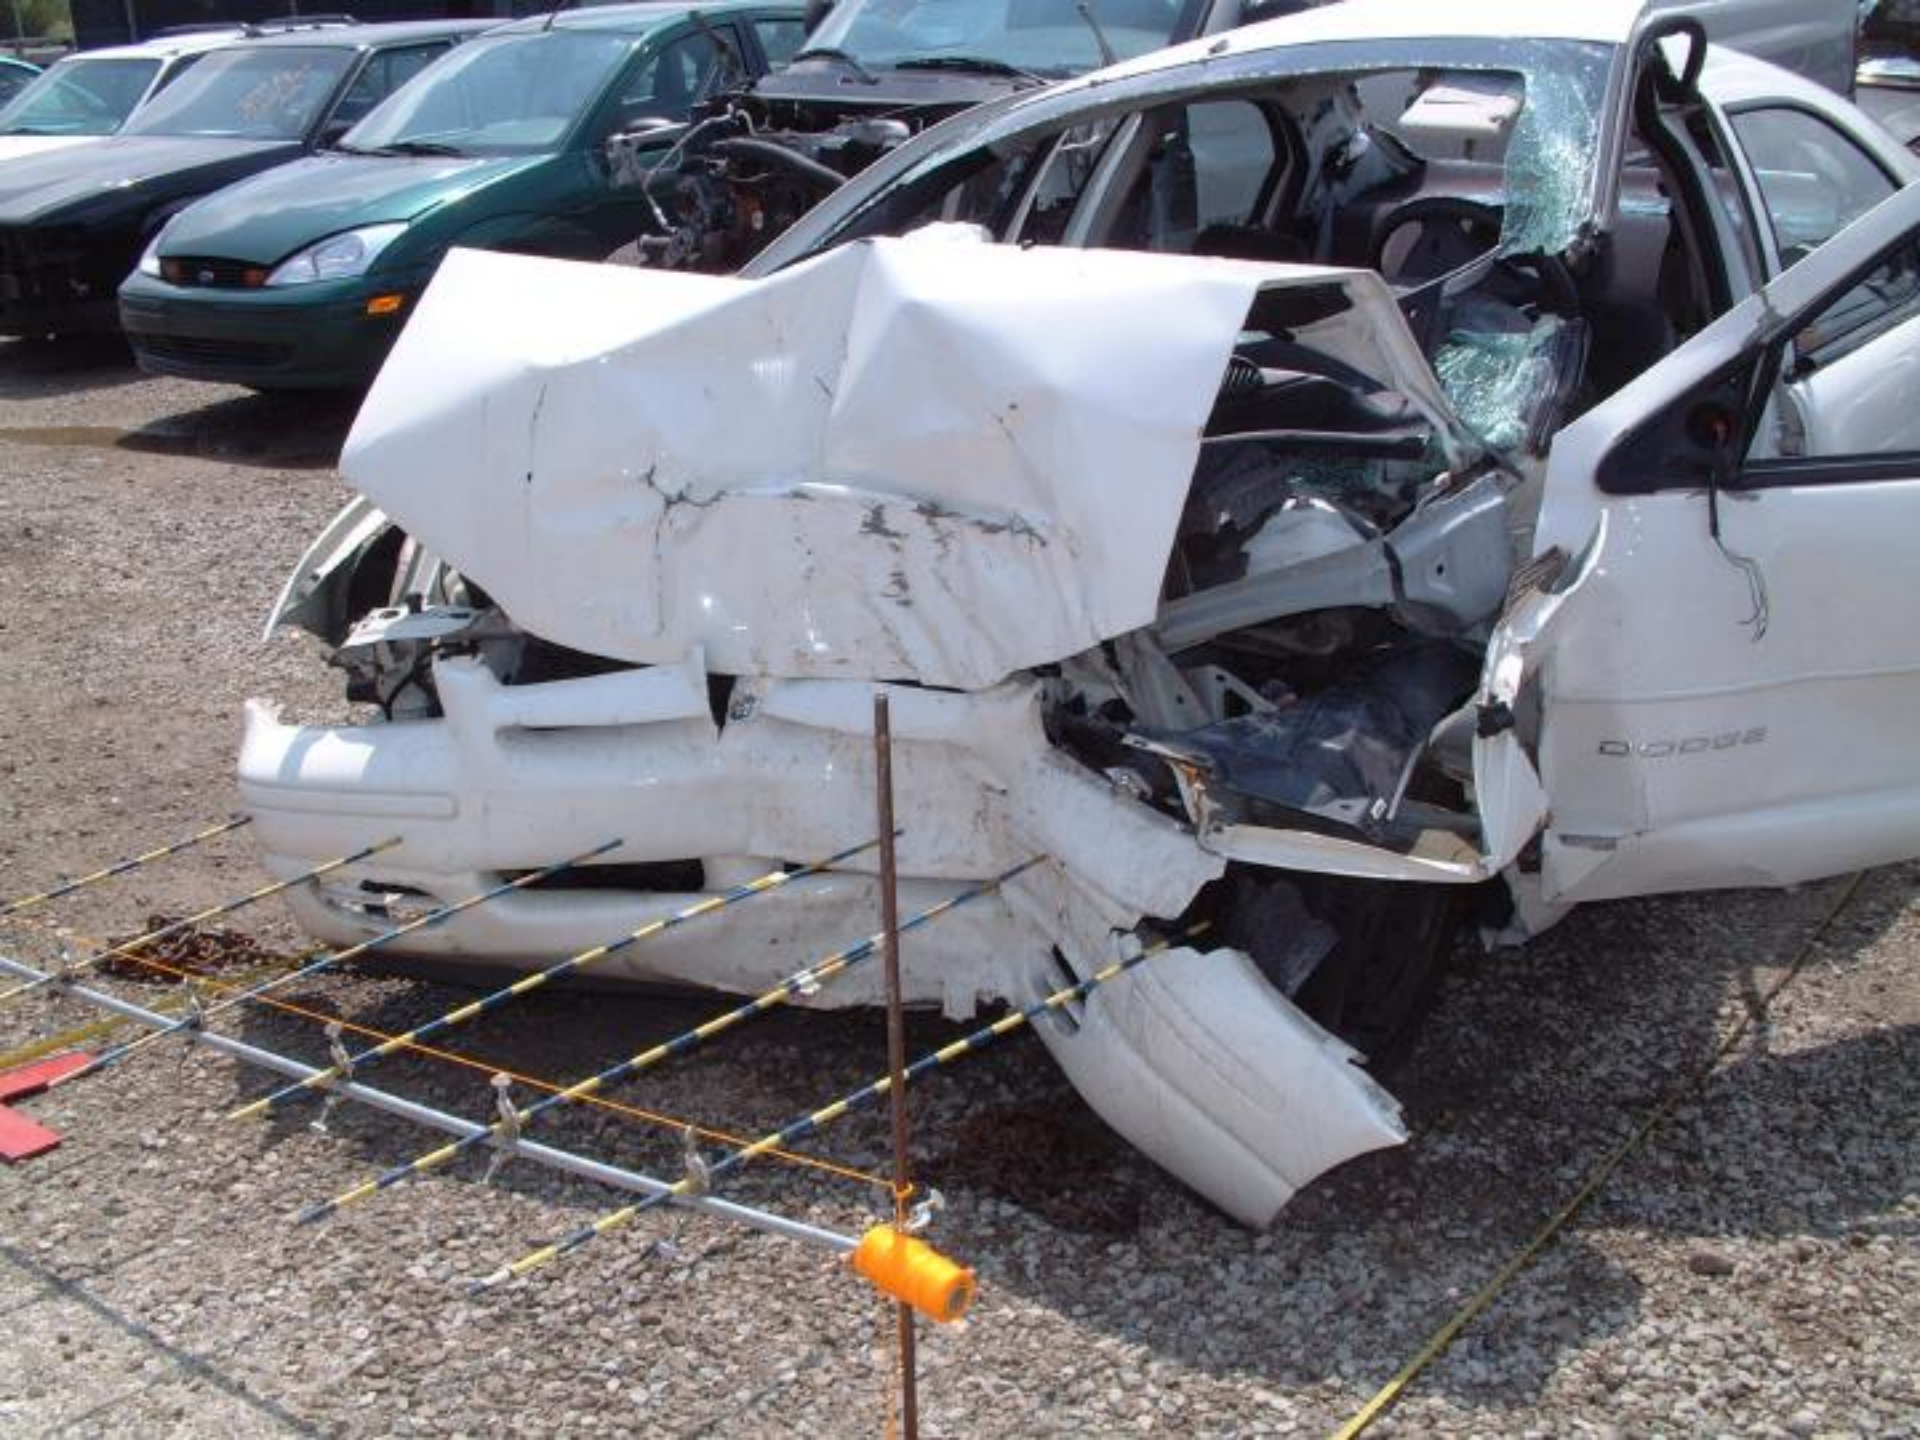
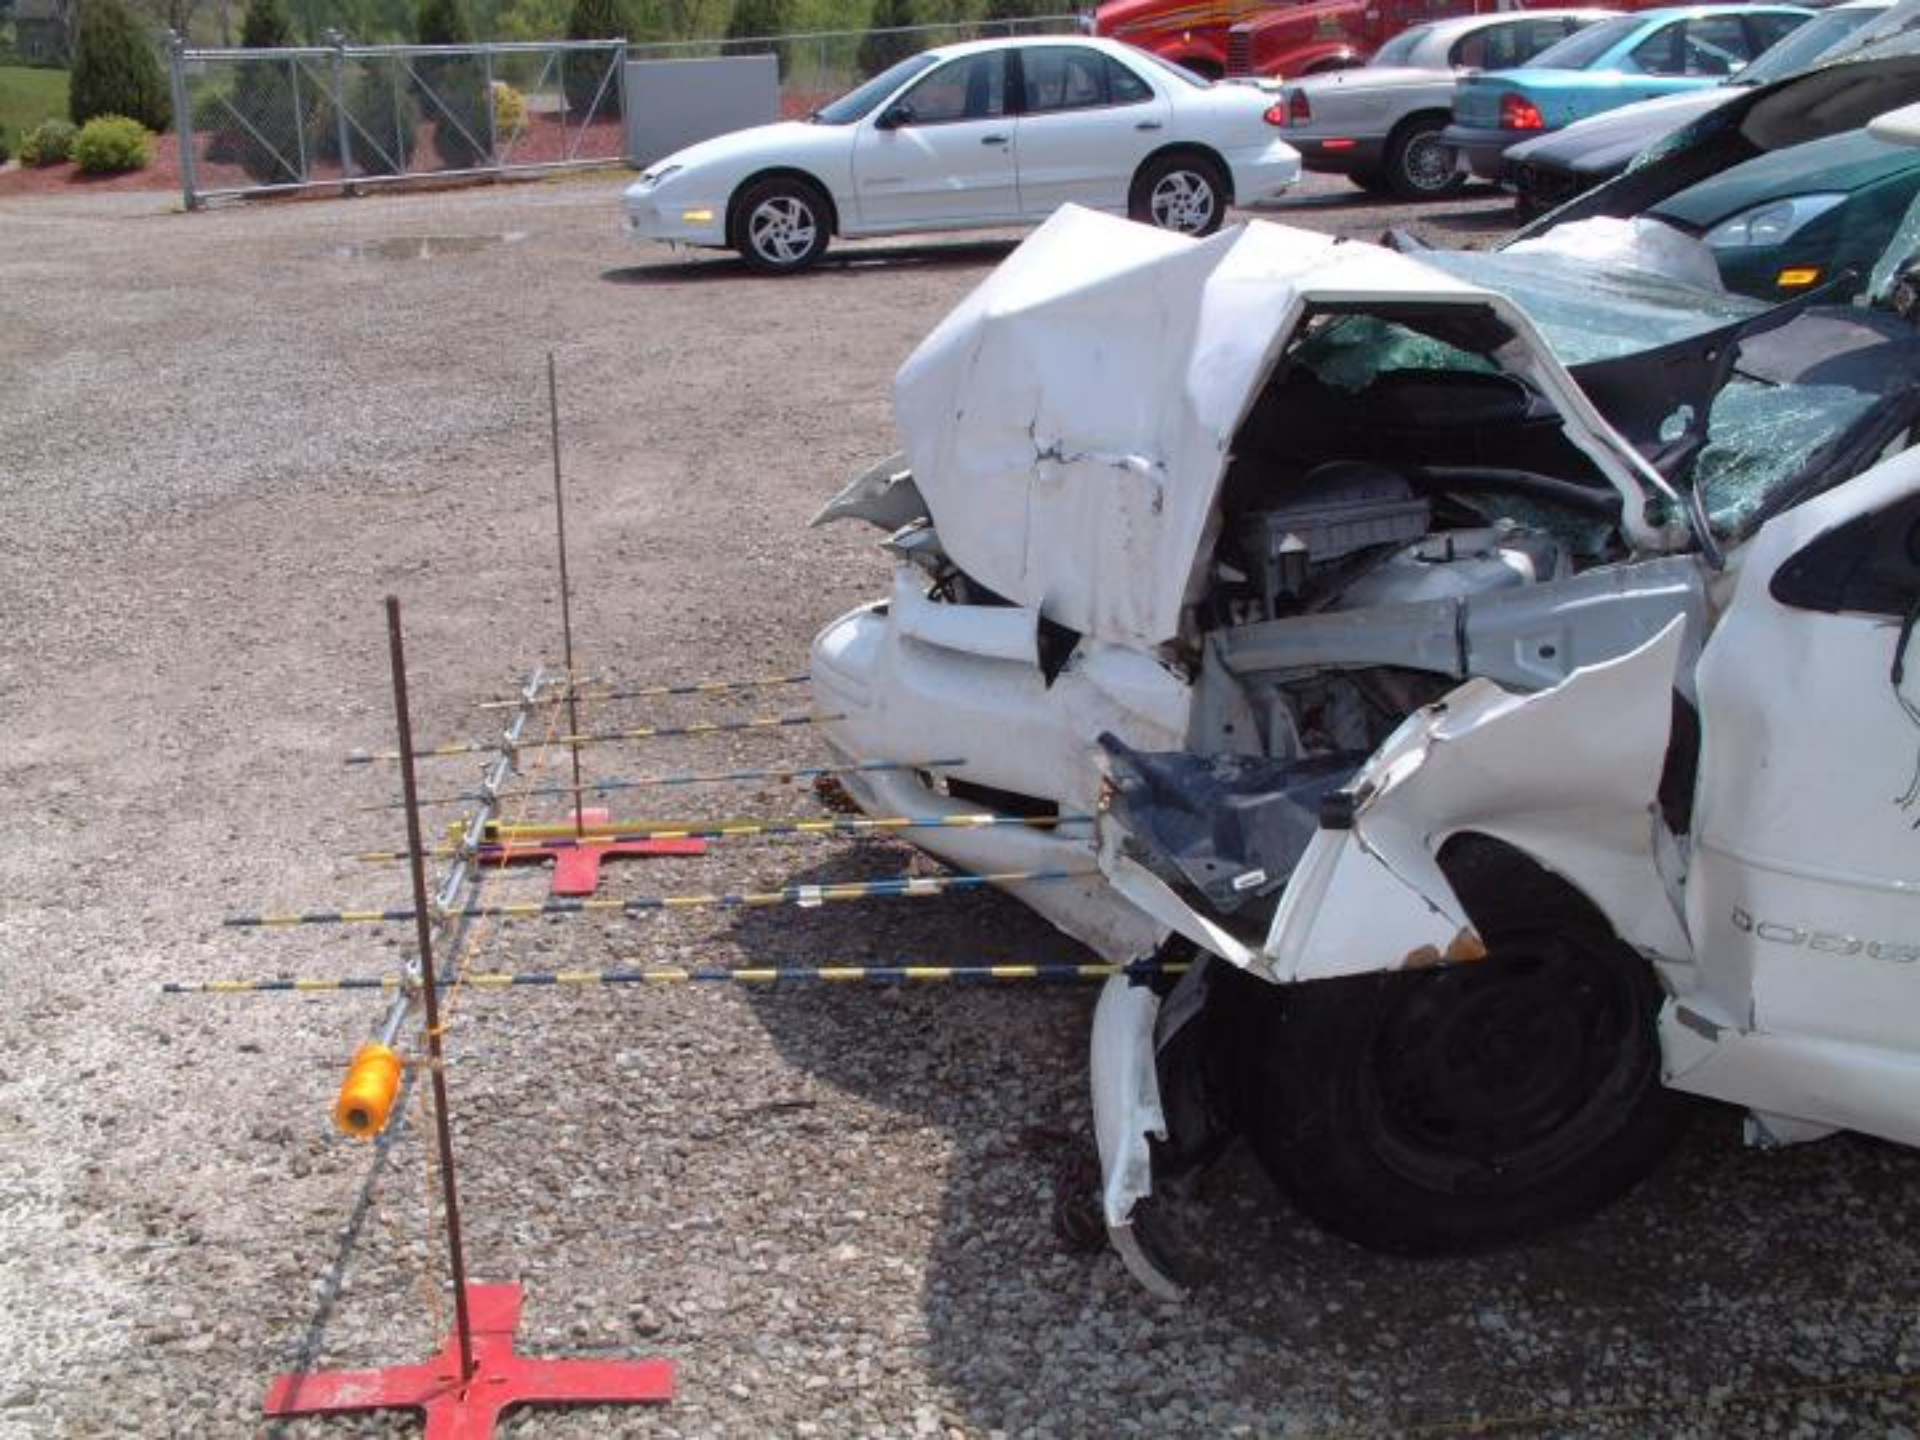
[25](#) [26](#) On the left side, the fender was crumpled rearward into the left-front wheel well. [27](#) The left-front wheel was damaged, the hubcap came off of the wheel, and the left wheelbase was reduced 32 cm. [28](#) [29](#) All of the upper pillars were cut to remove the roof for extrication of the driver. [30](#) There was no damage to the left B- or C-pillars and the left-rear door was undamaged and operational. The upper and lower portions of the left A-pillar were deformed, causing the driver door to be jammed closed, and [31](#) the left portion of the roof was buckled just above the driver door. There was extrication damage to the door latch and B-pillar. The driver door was buckled, the door window frame was bent, and the door glazing was broken. [32](#) There was also no damage to the left-rear quarter panel.
